---------- Original Message ----------
From: Stephen Best [sbest@cityofsantamaria.org]
Sent: 5/24/2024, 9:35 AM
To: libby.landers@flocksafety.com; support@flocksafety.com; jake.sherman@flocksafety.com; brendon.norton@flocksafety.com
Cc: elara@cityofsantamaria.org; dcohen@cityofsantamaria.org; sbest@cityofsantamaria.org; mbalcorta@cityofsantamaria.org; tteh@cityofsantamaria.org
Subject: And even more failures to read night plates

Today's test 05-24-24

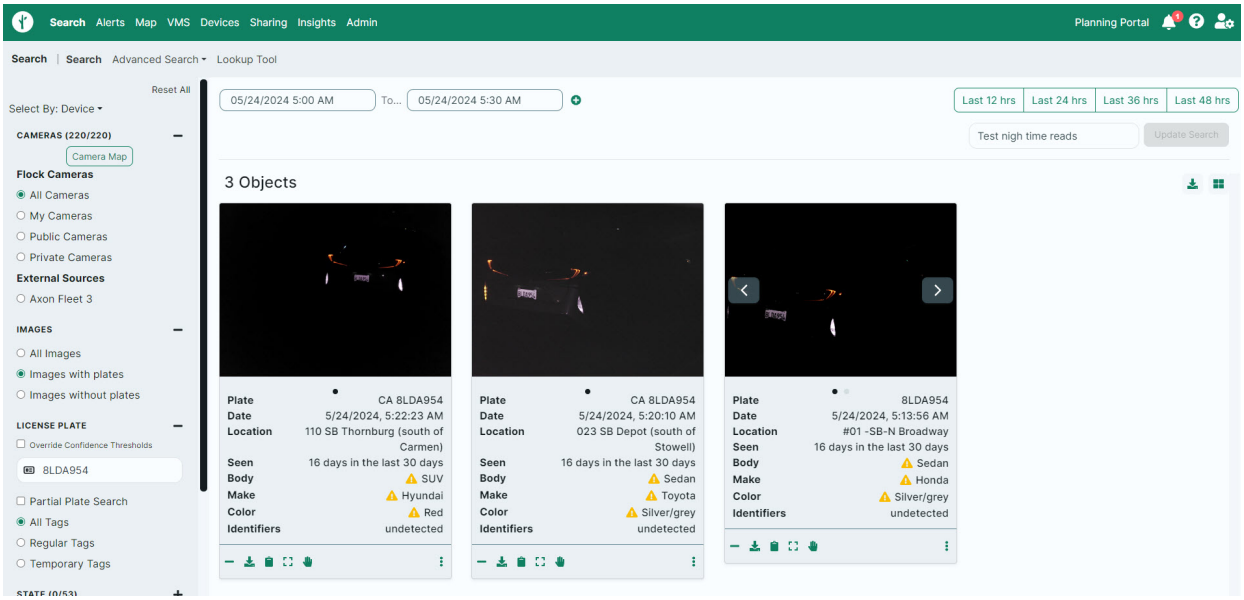
Of the 8 cameras I passed only 3 read my plate. That's about 37% success rate.

I searched all 220 cameras for 8LDA954 for 05-24-24 from 0500-0530 Hrs. Results=3 successful reads

Please add all these cameras to the list to be serviced.
